## Chandler House Renovation Updates

### Restoring the Chandler House

The Currier Museum of Art is renovating the George Byron Chandler House, an architectural treasure from the late 19th century that sits across the street from the museum. The main floor of the house preserves impressive stained-glass windows, original wallpaper, and fine wood carving. These areas will be open to the public as an expansion of the museum, specifically to represent New Hampshire in the 19th century.

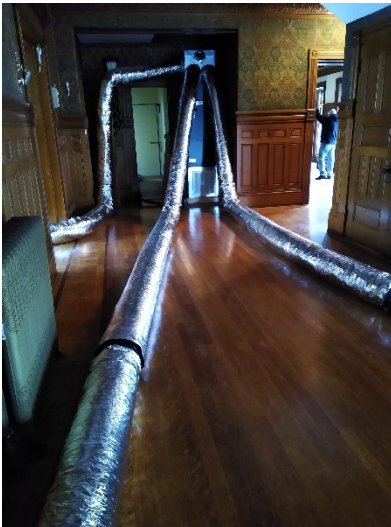
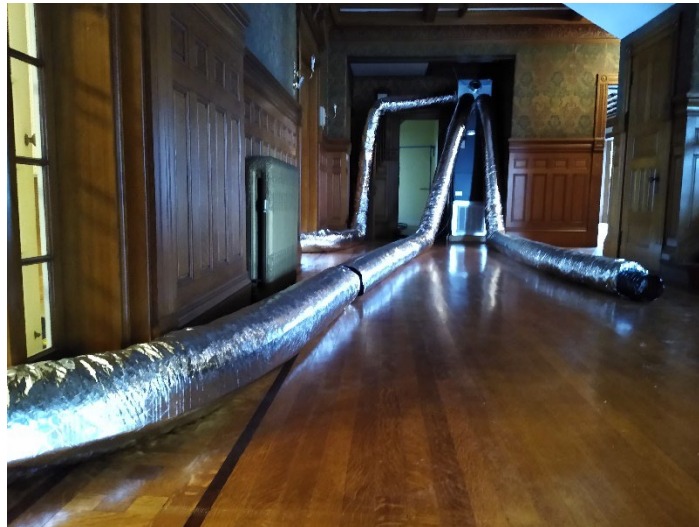
"Silver snakes" at the Chandler House:

Duct work from the temporary heating system has been set up to maintain a moderate but even temperature over the winter. We are using an energy efficient electric heat pump equipment and have placed units in temporary locations until construction begins in earnest. Once it is installed in the permanent configuration the system will provide heating and air conditioning throughout the house.

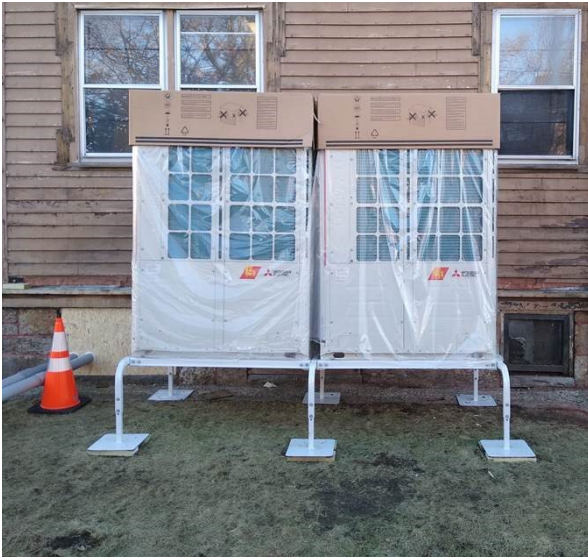
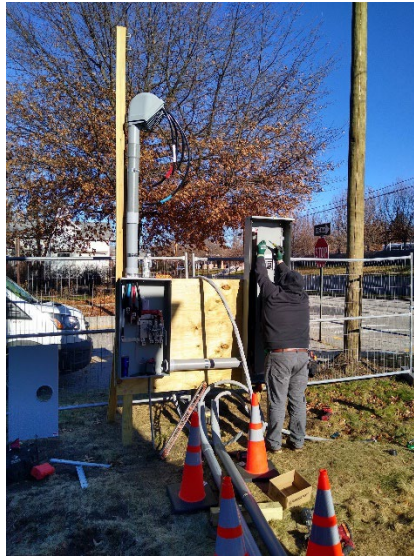
Electricians and heating specialists are hard at work installing and testing a heating system to protect the delicate interior finishes. The new system will run on an energy efficient heat pump. The permanent equipment is being installed in a temporary configuration until general construction is further along.

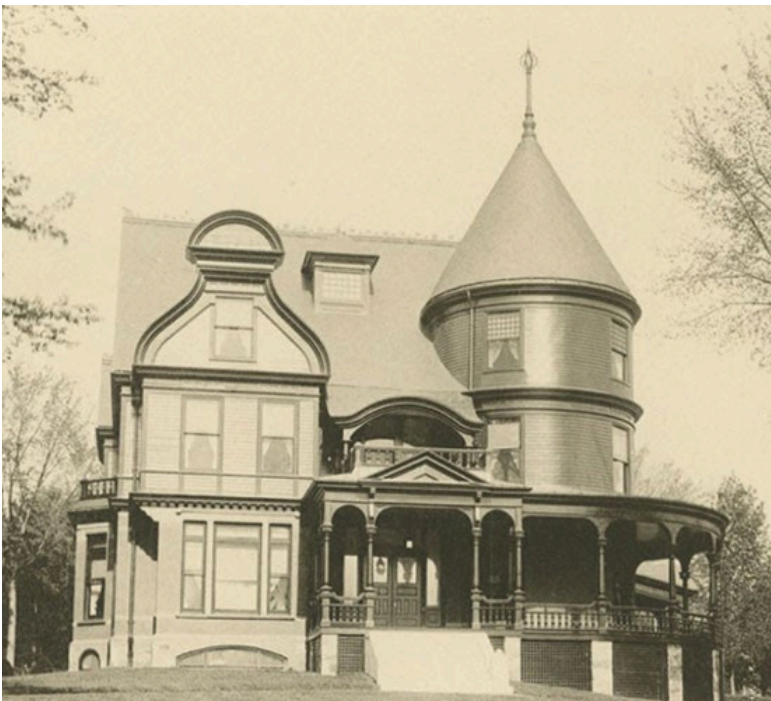
**December 2021**

Really?! That's the only photograph you have of the expanded Chandler house from the early years

Yes, unfortunately we have NO photographs showing the south, north or west sides of the house. Photo documentation is very important as we research what the original exterior decorative wood work and plan for its reproduction. If you have or know of old photographs with the Chandler house please send them our way!

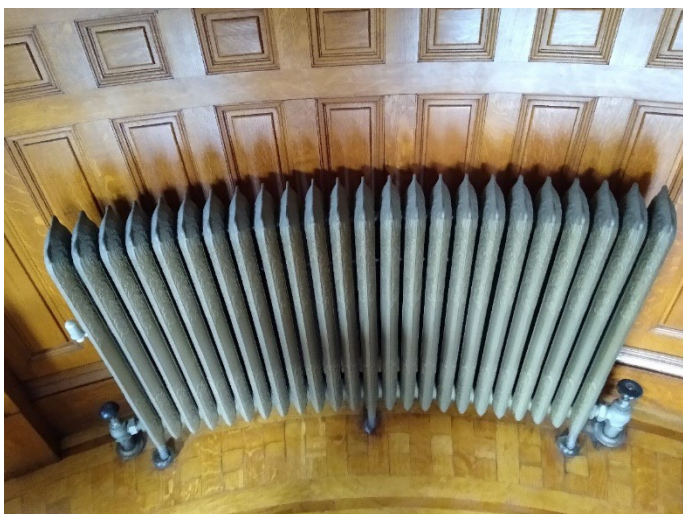
How do you heat a round room in 1890? With a curved radiator...

The Chandler House Great Hall includes a round turret room. Custom-made, radiators were constructed to follow the curve of the walls. They are decorated with a fine filigree pattern.

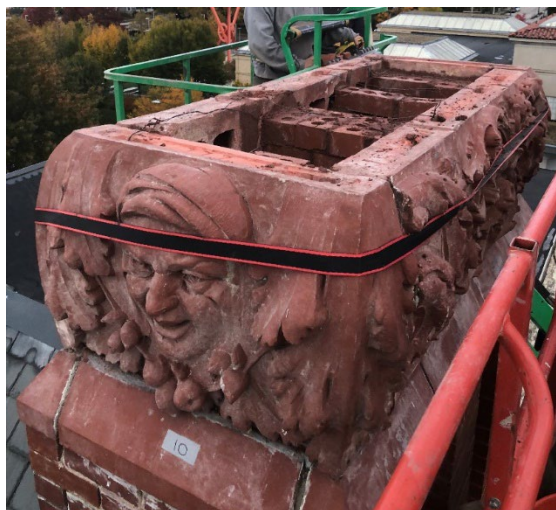
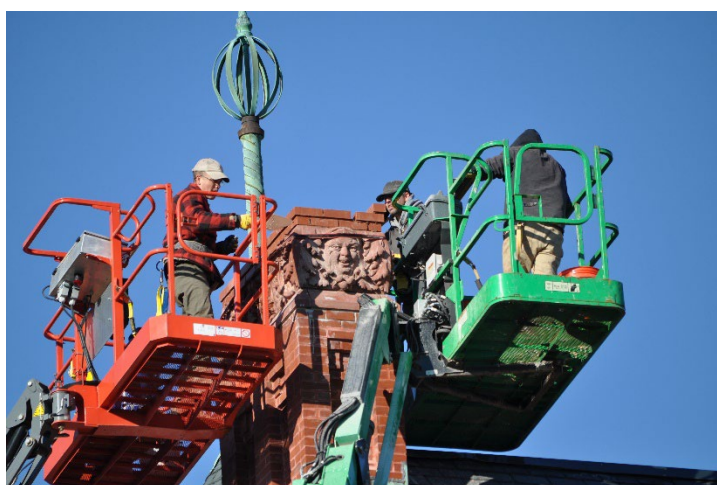
They're back! The terracotta sculptures of faces are once again high atop the chimneys on the Chandler house.

Chimney repairs and the repointing of brick work are almost complete meeting one of the Currier's primary preservation goals ahead of the winter weather.

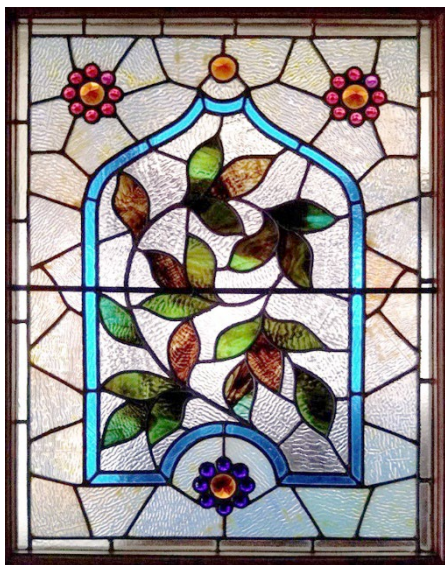
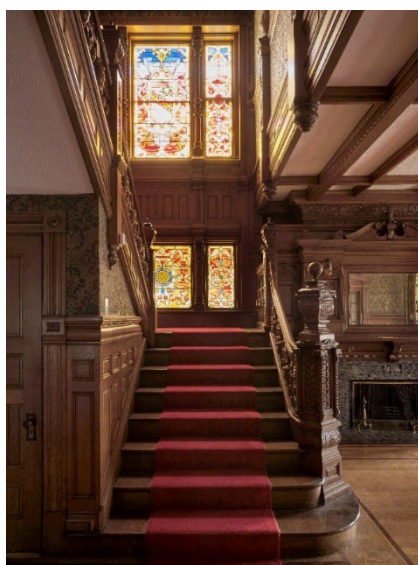
The grand staircase in the Chandler House glows with warm light from the two-story stained glass window. There are 17 stained glass panels in the main rooms. The dramatic windows are decorated with a variety of interlacing botanical and abstract designs.

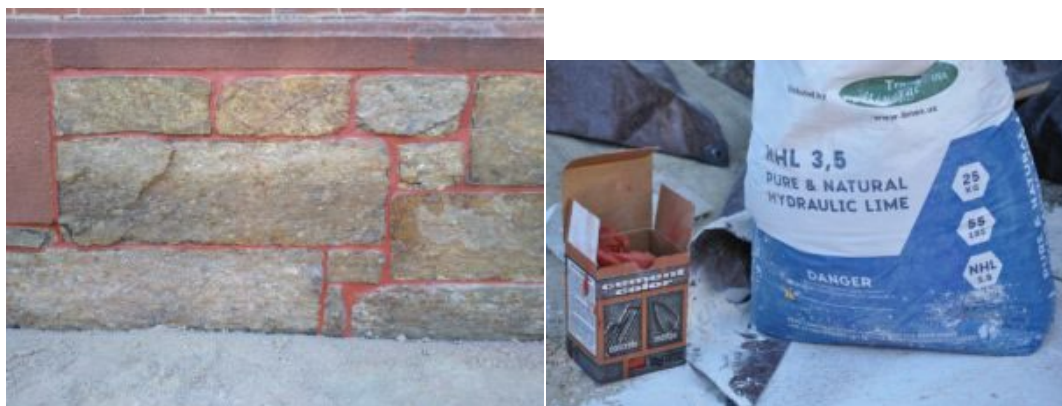
Red mortar? Yes, analysis revealed that mortar on the Chandler house was red, so repointing is being done in red.

Mortar actually does not contain cement, just pure lime, sand, and water. The recipe for Chandler red mortar is 2 parts lime, 8 parts red pigment, 6 parts sand. Add water to desired consistency and stir – like moist granulated sugar.

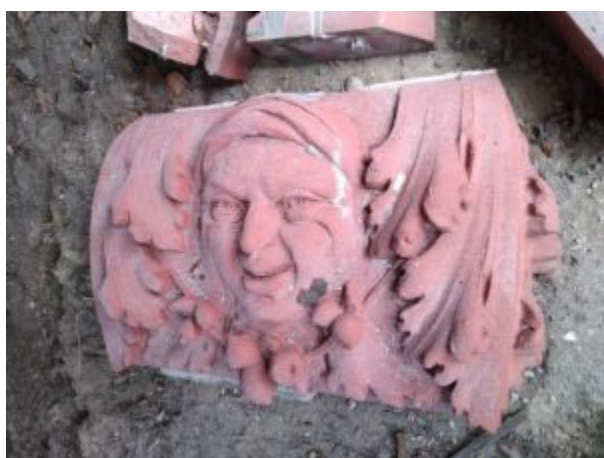
This cheery fellow, and the decorative foliage surrounding him, is from the top of the south chimney. The upper three feet of the chimney were dangerously unstable and were dismantled by the preservation masons. The terracotta sculptures are in good condition and will be reinstalled as the chimney top is reconstructed. Want to get involved? Make your gift today!

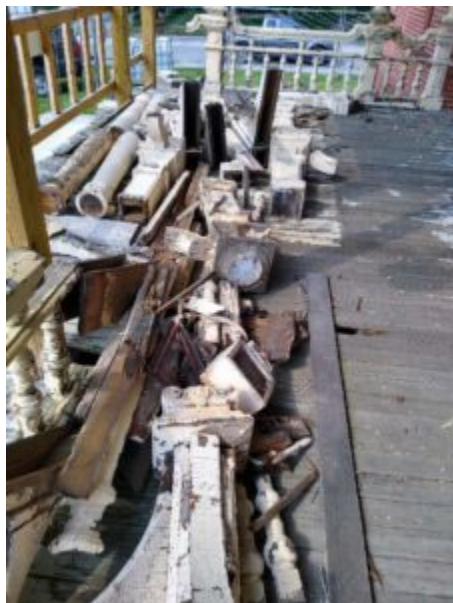
Columns, bannisters, and railings from the deteriorated porch are being inventoried. Pieces in good condition will be restored and reused. Where necessary, new parts will be constructed to closely match the shape and materials of the originals. Over 250 feet of custom railing and 300 turned parts make up the decorative woodwork on the wrap around front porch.

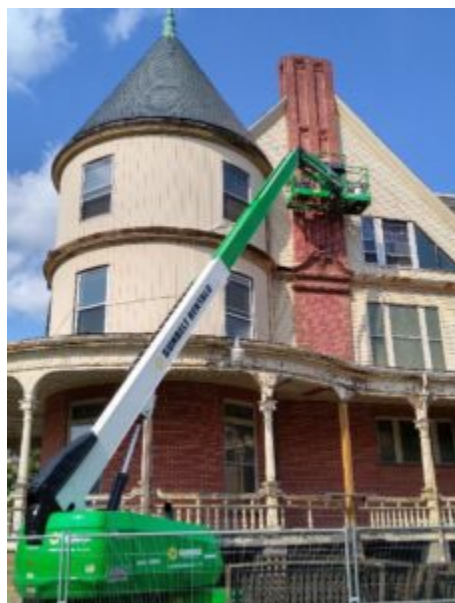
You may have noticed that preservation masons have begun work on the Chandler house. The beautiful chimneys are being repaired and repointed and the crumbling north east wall is being reconstructed to protect them from another harsh New Hampshire winter.
